2006 WBA Remodeling Awards

“Photogenic Features”

DEGNAN
DESIGN BUILDERS
INC.

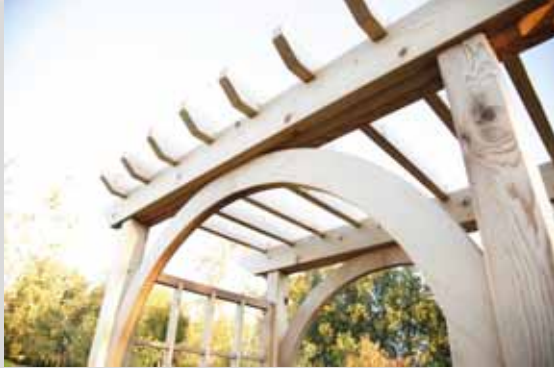
The arches were cut from cedar dimension lumber.

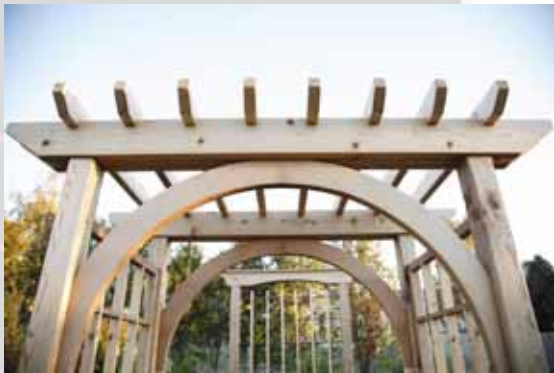
The top members are carefully notched to fit over the cross beams.

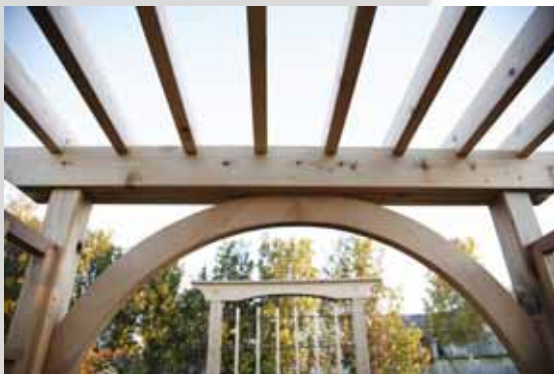
The side lattices were ripped from dimension lumber and precisely dadoed to fit.

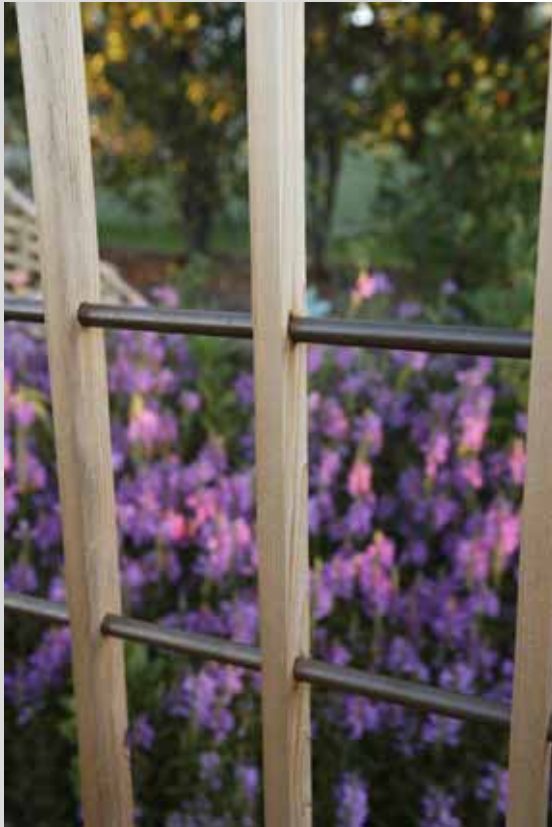
Copper pipe was cut to fit, and the cedar uprights were precisely drilled to receive the pipes. Through only one summer, the pipes have already begun to show their natural patina.

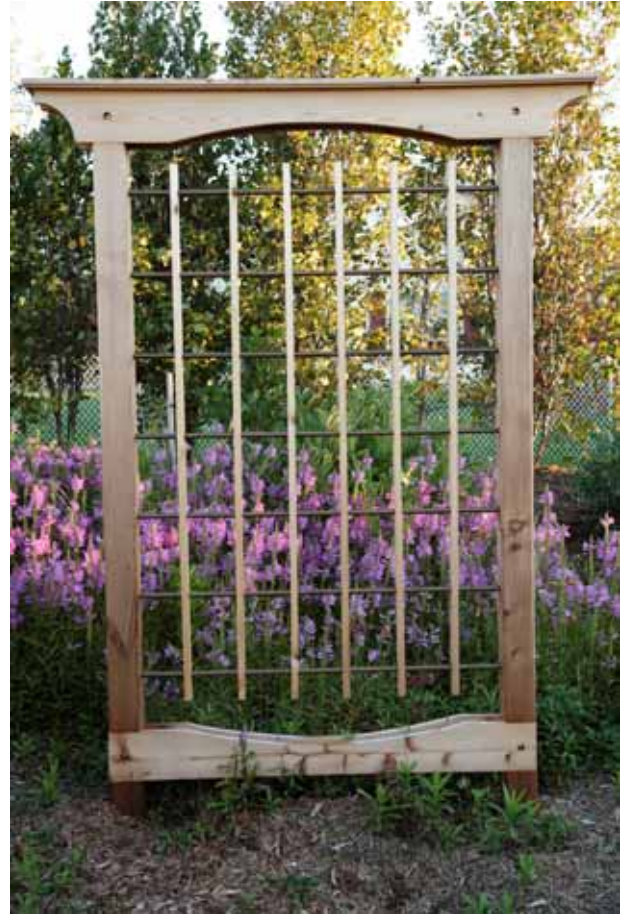
The width of the trellis was expanded slightly from the plans to provide the size and scale preferred by the client.

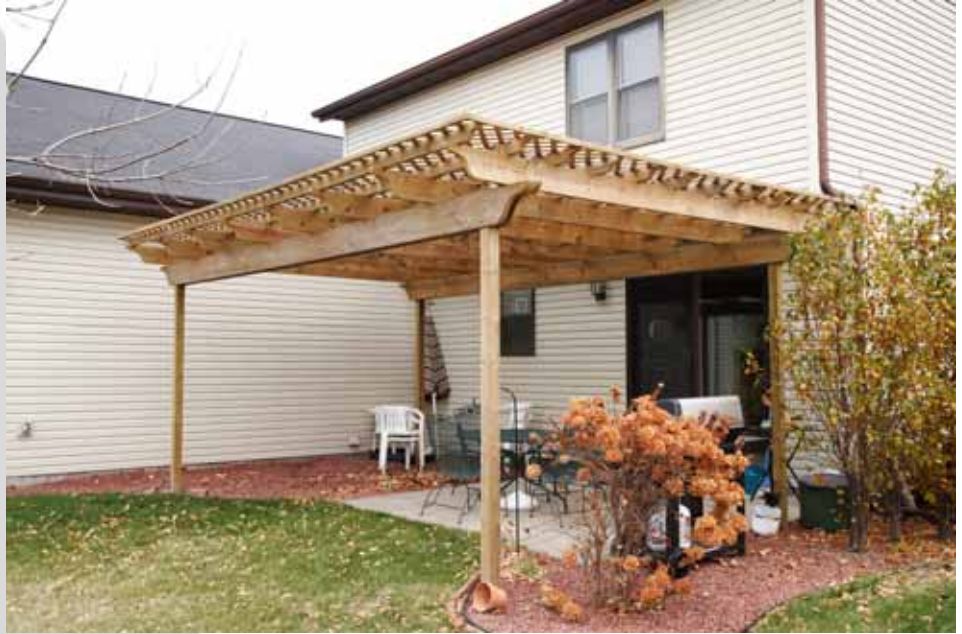
The pergola helps to break up a series of walls that have little glass. The south exposure collects much sunlight and heat. The new pergola shades the patio door and window, allowing filtered light while minimizing glare and excess heat gain into the house.

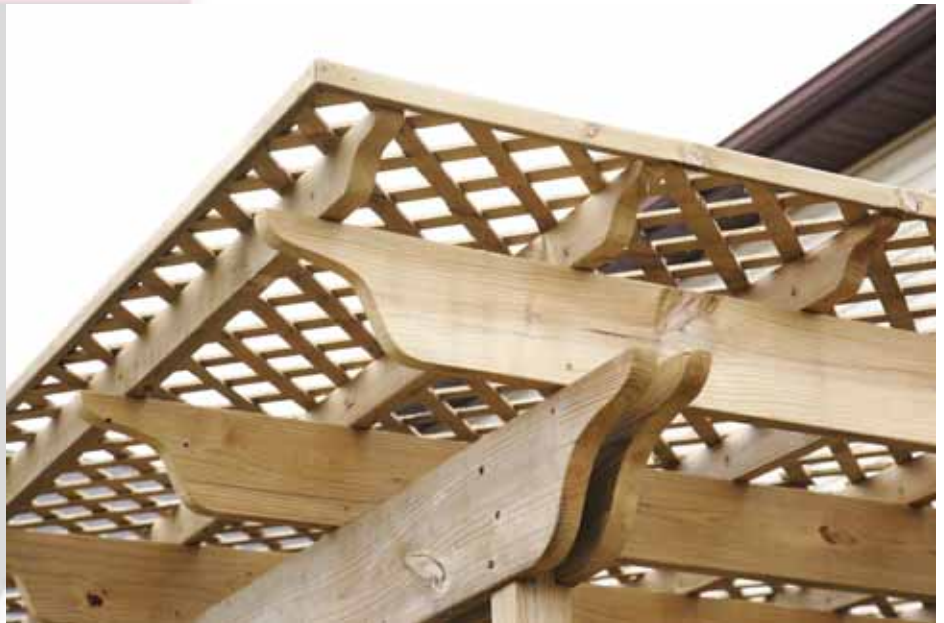
Above: A detail of the completed pergola shows the improved edge detail of the lattice, and the extra character created by spacing the main beams apart sandwiched over the 6x6 support post.
